Manhole Inspection Summary

Manhole # S41SS_008MH

Insp Date: **2/19/07 10:47 AM**

Location Address: **2601 GARRETT AVE**

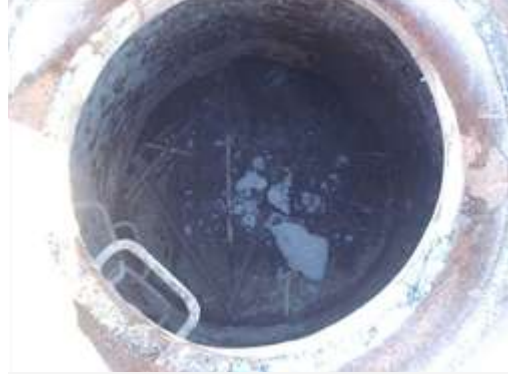
Top View

Barrel infiltration. Channel debris.

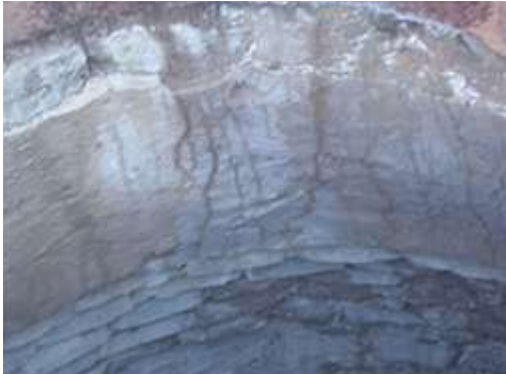
Defect

Condition: ☐ Sound ☐ Cracked ☐ Root Intrusion ☐ Loose Brick ☒ **Deteriorated**

Infiltration: ☐ None ☐ Joint ☐ Cracks ☒ **Mortar** ☐ Roots ☒ **Wall**

Corbel and Barrel deterioration and infiltration.

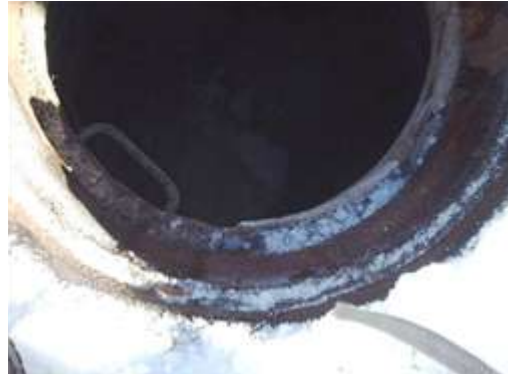
Defect

Frame leaks. Frame offset. Adjustment deterioration and infiltration.

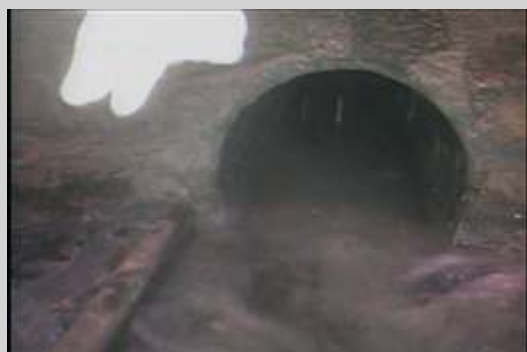
Pipe Out @ 12 O'Clock

Deposits: ☐ None ☒ **Mud** ☐ Sludge ☒ **Debris** ☐ Grease

Deposits Extent: **Light**
